A new lease of life: Drewstead Bridge, London

Drewstead Road Bridge in Streatham Hill, London Borough of Lambeth, carries the B221 across the main railway line just west of Streatham Hill Station. It is a significant transport route for Lambeth with bus routes, commuting pedestrians, heavy goods and light vehicles constantly crossing the bridge. The current bridge, which was built in 1968, comprises precast, prestressed concrete bridge beams spanning the railway lines supported by two sets of four circular columns and a crosshead beam (see Figure 1). In 2012, after a thorough investigation and testing of the bridge structure, it became evident that repairs to the superstructure and the supporting columns and crosshead beams were required. After extensive planning and organisation of Network Rail possessions, in 2014 the bridge underwent a large-scale refurbishment to extend the life of the structure by at least another 25 years. **Michael Balletta of Concrete Repairs Limited (CRL) and Tony Parasram of Free4m Consulting report.**

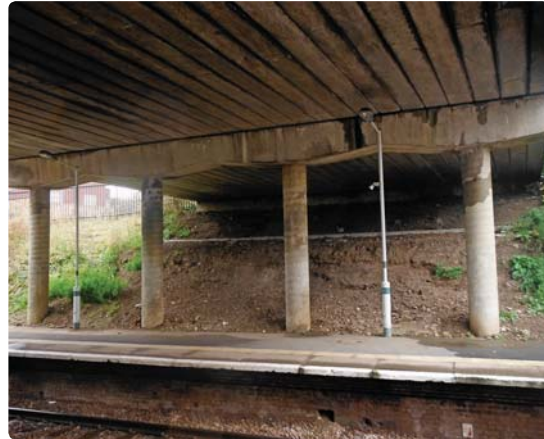
Figure 1 far right: View of southern substructure showing typical cross head beam and four circular columns.

At the time of the inspection, carried out from the railway corridor, a number of the circular columns exhibited significant cracking along their height with some concrete spalling to the crossheads. Water staining on the elevations of the crossheads was evident, with a pattern of staining, cracking and spalling commensurate with the likely path of stormwater percolating past the bridge joints.

Upon completion of the special inspection, the decision was taken to immediately design and install 'interim' measures to structurally support the distressed columns. Circular steel banding was fitted during engineering hours as a temporary support measure allowing further investigation to be safely carried out.

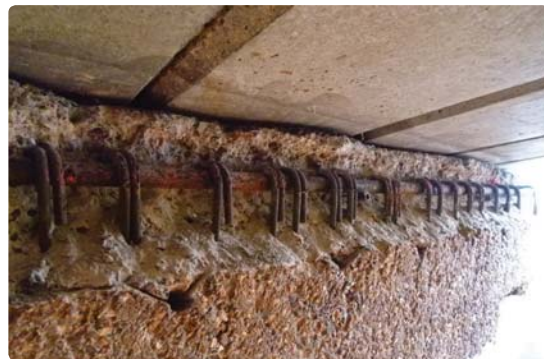
Figure 2 far right: Typical area of spalled concrete on top edge of crosshead beam.

Observations made at top-deck level noted cracking in the carriageway surfacing in line with each buried joint, allowing chlorides from the de-icing salts used during winter to saturate areas of the crosshead beams and penetrate into the concrete, thereby increasing the likelihood of reinforcement corrosion.

Large areas of spalling had also begun to take place, indicating that the chlorides had reached the depth of the steel and destroyed the passivity around the reinforcing normally found in good concrete (see Figure 2).

Hydro-demolition was again used to remove the defective concrete, with crosshead repairs limited to localised sites. Removal of defective concrete again was specified to behind the existing reinforcement with reinstatement carried out using either a flowable micro-repair concrete, or a proprietary repair mortar as appropriate.

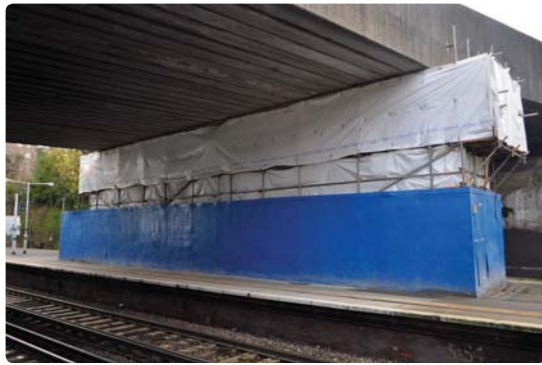
Figure 3 right: North substructure showing the hoarding/enclosure of the work.

Detailed design followed with the final works methodology developed through close collaboration between CRL, FM Conway and Free4m. It was agreed that all works within the railway corridor were achievable within a fully enclosed hoarding situated at railway platform level, thus establishing a 'green zone' and effectively removing all risk associated with possessions, cancelled possessions, etc (see Figure 3).

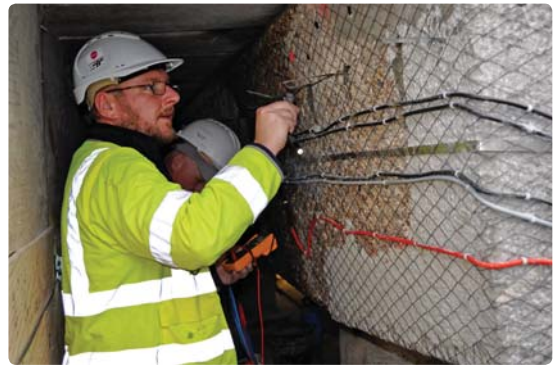
Figure 5 far right: Testing for shorts in the CP system prior to applying overlay with the spalled areas repaired and the beam prepared with the MMO titanium fabric and wiring ready to receive the overlay.

Split into two zones, the ICCP comprised mixed metal oxide coated titanium (MMO/Ti) expanded mesh anode encapsulated within a sprayed concrete overlay for Zone

1 (the majority of the crosshead elevation, underside and ends) and 19mm-diameter discrete anodes of MMO/Ti along Zone 2 (top of the crosshead) drilled into the crossbeam for the protection of the bearing shelf (see Figure 5).

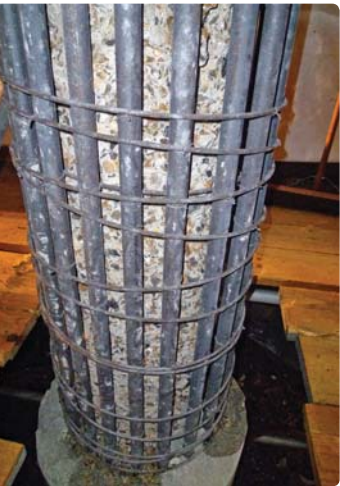
In reality, the condition of the column reinforcement was very good, with the most significant deterioration located at the top, as expected.

Figure 4: Column with defective concrete removed awaiting recasting.

All loose, cracked, delaminated and substandard concrete was removed using hydro-demolition, as opposed to mechanical breakout, and carried out within the 'green zone' at 10,000–12,000psi (690–827 bar) to remove the defective concrete off the structure, while maintaining sound parent material. Concrete removal was specified to a depth of approximately 30mm behind the existing column reinforcement to ensure existing reinforcement was fully enclosed in the repair material (see Figure 4).

Repair of the column sections was then carried out in 900mm lifts to the full circumference of the column. The design team established that, with live load relief, a full circumferential repair was achievable in one go.

To ensure that the design assumptions facilitating the full circumferential repair were sound, a window sample of concrete was removed at the top of the worst column to observe the condition of the reinforcement. The condition was as expected and the designed methodology employed. Each lift was reinstated using a proprietary flowable micro-repair concrete.

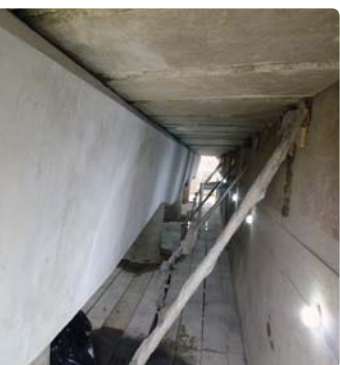
Figure 6 below: The completed crosshead beam with the overlay applied.

All cabling was taken along the crossheads to the portal ends, up through the parapet, discreetly to a cabinet located at bridge deck level prior to the mesh and wiring being overlaid with a special CP spray-applied mortar (see Figure 6).

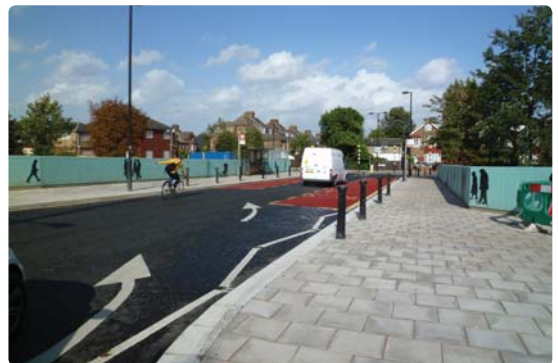
Figure 7 far right: The completed superstructure with new joints in place and re-asphalted.

The refurbishment and repair of the Drewstead Road Bridge, over an operational mainline railway station, within a residential community and on a main trunk route was, in the main, a conventional and run-of-the-mill repair project. The success of the project lay primarily in the collaborative working between London Borough of Lambeth, CRL, FM Conway and Free4m. This meant establishing a methodology, which substantially mitigated the risk of working in a highly controlled and restrictive environment, enabling the refurbishment works to be completed in 4½ months without incident, within budget and to programme. Early contractor involvement, a proactive client and a forward-thinking engineer also contributed to the ensuring that the structure will withstand the ravages of time and the elements for a further 25 years (see Figure 7). ●
