# Iconic Bristol water tower restored

With the emphasis over the past decade on carbon reduction, and the pressure on water companies to prove and maintain their sustainability, the repair and refurbishment, as opposed to demolish and replace, of concrete assets in the water industry remains the norm, but now with more prominence on whole life cycle assessment. **By Michael Balletta, Infrastructure Manager at Concrete Repairs Ltd.**

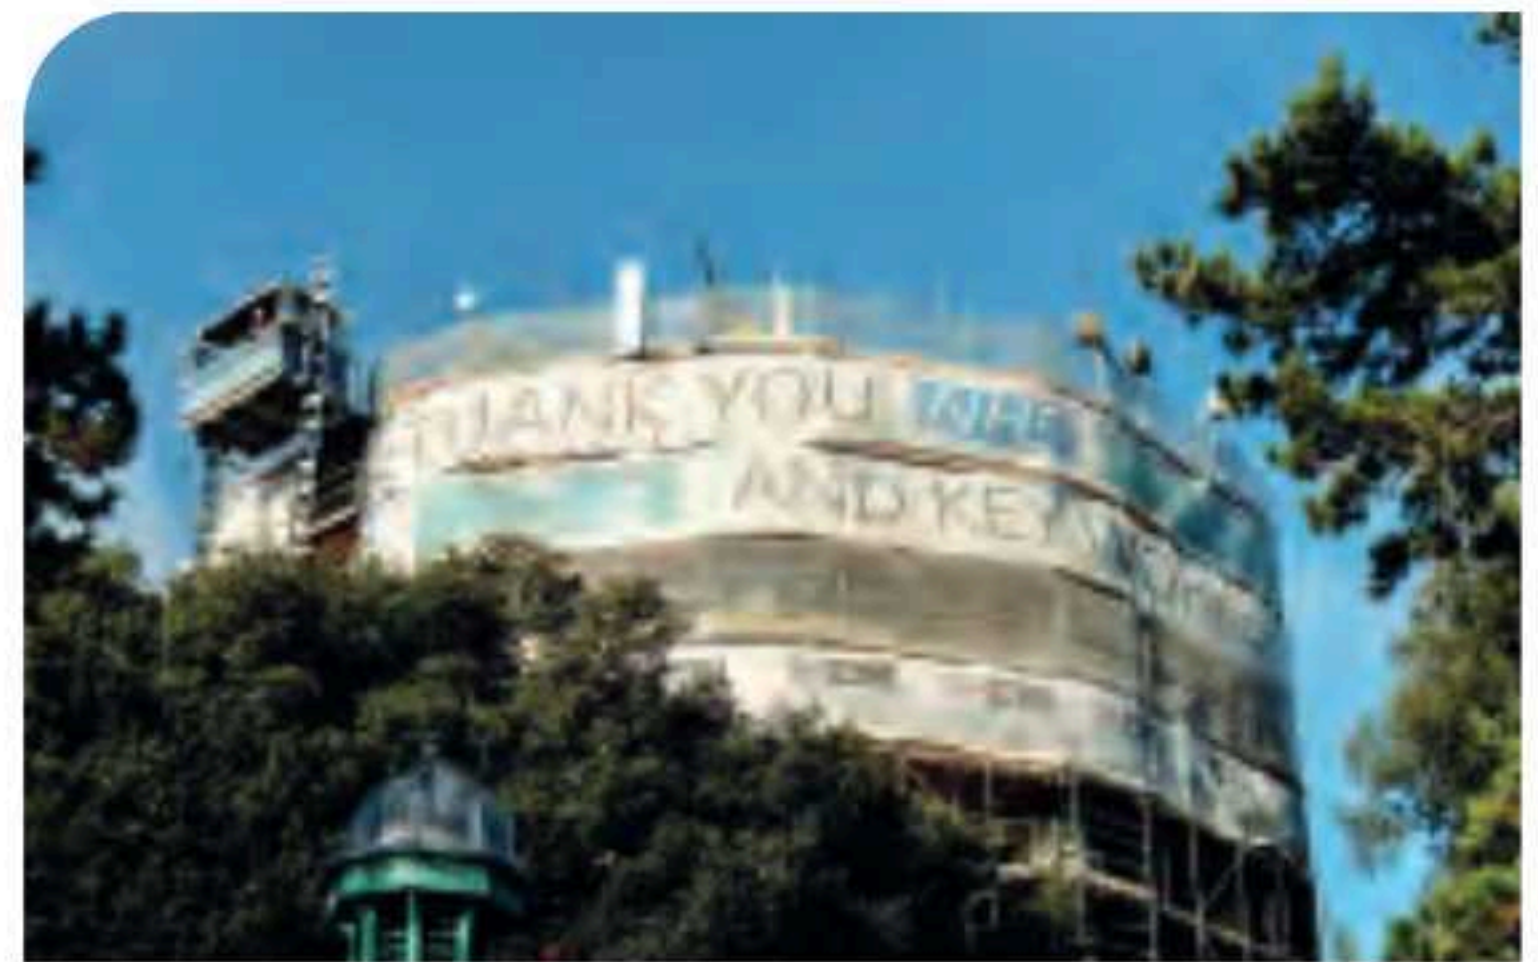
In order to carry out the works, a significant scaffold was required to be

erected around the tower to enable access to the external elevations. A passenger goods hoist was also installed to the full height of the scaffold.
