ENGINEERING AN INNOVATIVE SOLUTION TO WATER TOWER LONGEVITY

By Mike Balletta
Infrastructure Manager
CRL

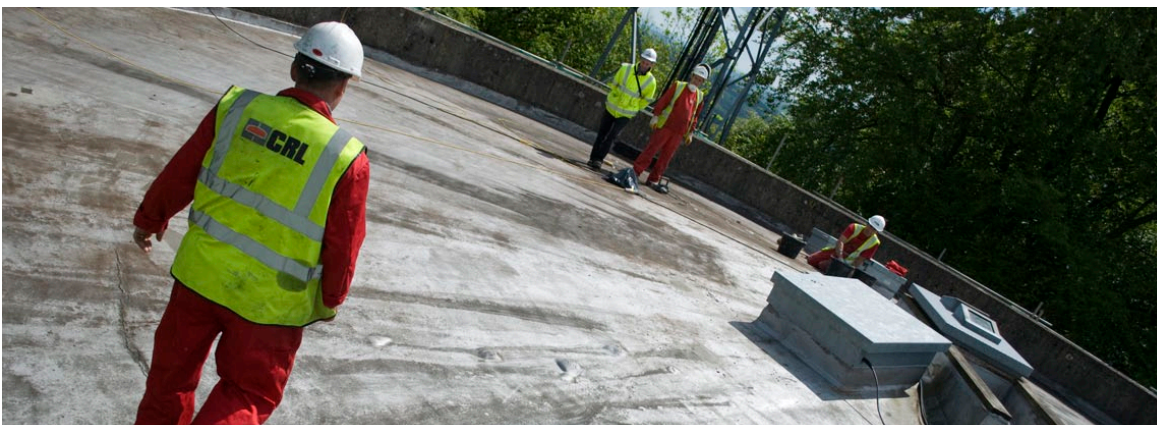
CRL at work on top of Rusper Watertower

The external works comprised all the exteriors surfaces of both towers, over the roof parapets, the waterproofing over the bowls and included the enclosed area under the bowls. CRL needed to identify and repair all spalled and cracked concrete, prepare all concrete surfaces and apply an elastomeric anti-carbonation coating.

The areas requiring an anti-carbonation coating at each tower were large, and CRL realised that this demanded an innovative approach to ensure application was time and cost effective. After extensive trials of different machines CRL applied over 2,000m² in three coats in just 10 days using a spray-application technique. Finally, as part of

the external works a WRAS approved anti-slip waterproof membrane was applied on top of the existing asphalt over the bowl.

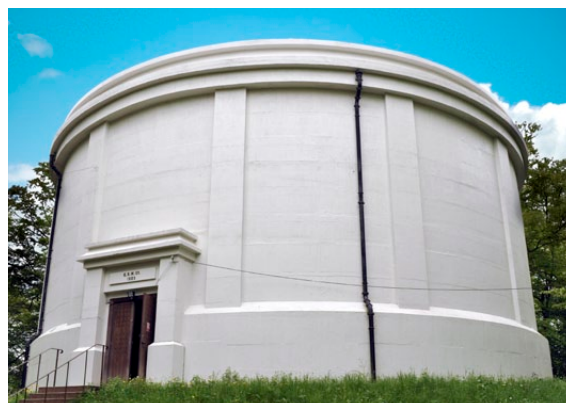
Rusper Watertower at the end of works

For the interior refurbishment of both towers the existing asphalt was removed and repairs to the walls and floor carried out where necessary. All of the surfaces were then grit blasted, levelled using a fairing coat and then relined with a DWI approved polyurea lining system, suitable for potable water structures. Repairs to all spalled and cracked concrete and the application of a protective coating to the internal soffits and beams was also necessary. Finally, to enable easy access and egress to the towers, stainless steel internal access ladders were fitted to both towers.
