# ISOCYANATES AND BIOLOGICAL MONITORING

Isocyanates are used in materials commonly found in the construction (and motor) industry – they are often found in paints, coatings, glues, foam, insulation, fibres, etc. Not all isocyanates are the same. **Nigel Roper** of **Concrete Repairs Ltd** reports.

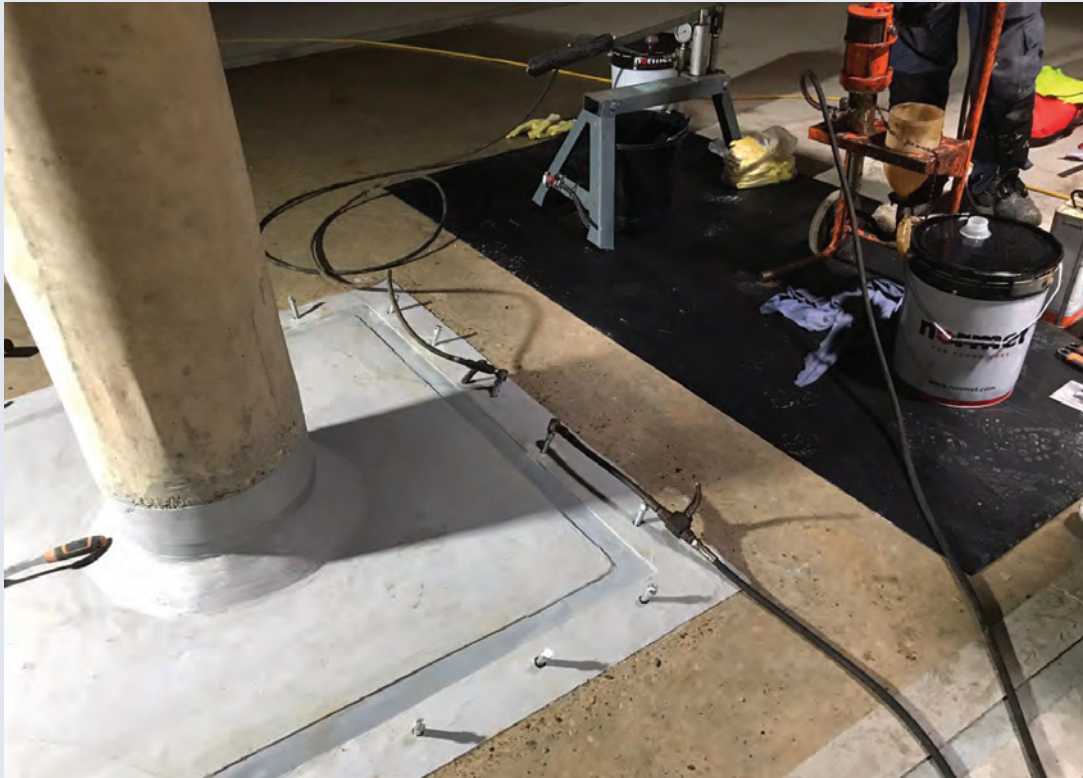
**FIGURE 1 ABOVE:**

Resin injection to column base.

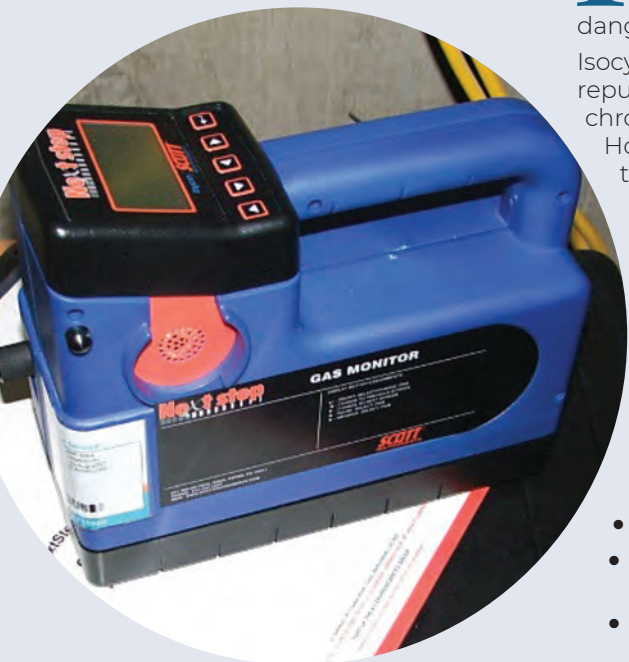
**FIGURE 2 BELOW:**

Isocyanate and semiconductor gas monitor.

In 2007, the company conducted atmospheric grab sampling (during resin injection for waterproofing) using a next step isocyanate and semiconductor gas monitor (see Figure 2). The results showed likely exposures to be extremely low, and in any case well below the workplace exposure limit published in the Health and Safety Executive's *EH40 Workplace Exposure Limits*<sup>(1)</sup> and the material safety data sheet.

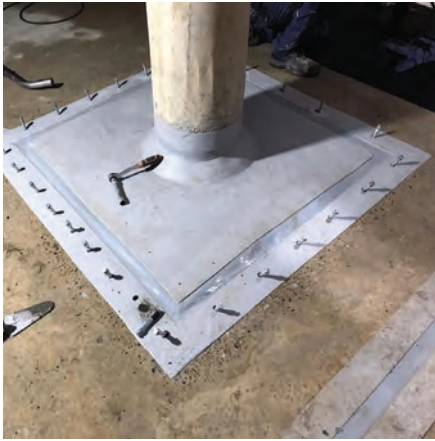
**FIGURE 3 TOP:**  
Resin injection to column base.

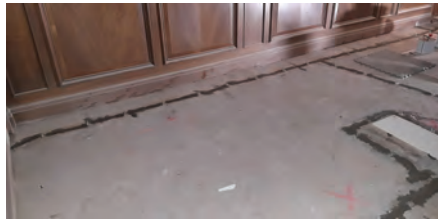
**FIGURE 4 ABOVE:**  
Resin injection to floor.

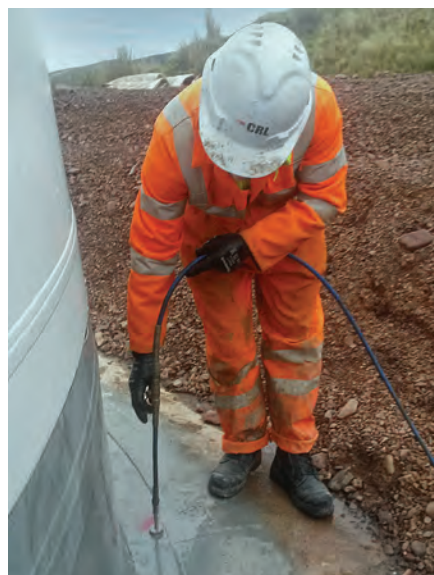
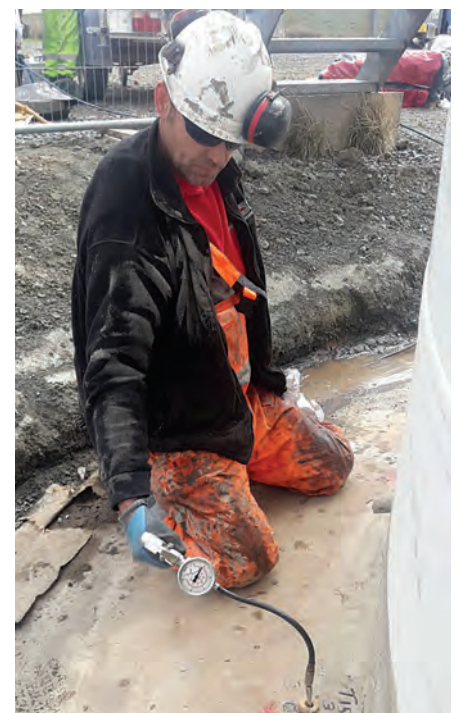
### FIGURES 5 AND 6 BELOW:

Resin injecting wind turbine bases at Aikengall windfarm.
